Rehabilitation based on original building plans of 1905 designed Bistrita Cultural Centre, Romania

Abstract

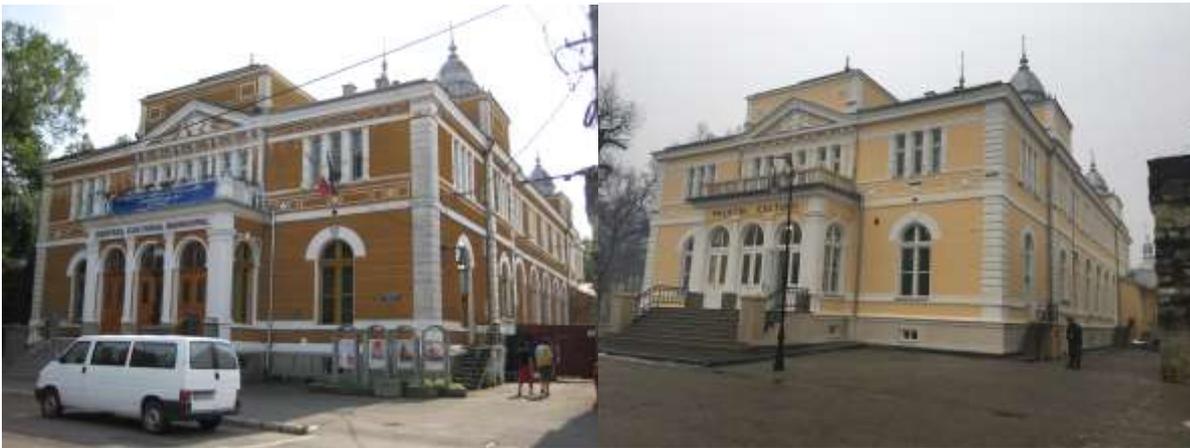
The building was diagnosed with: deep dampness in higher elevations, deformation of the slabs, fissure of walls and arcs, torsions and deformations of the roof frames, missing of certain structural wood beams and several finish degradations. The buildings concert hall was also diagnosed having very bad ventilation and heating system, bad visibility chair placement towards the scene and a lot more minor problems.³

Figure 1 - Before and after Main access of the Cultural Center “George Cosbuc”
credits: Rares V. DRAGAN

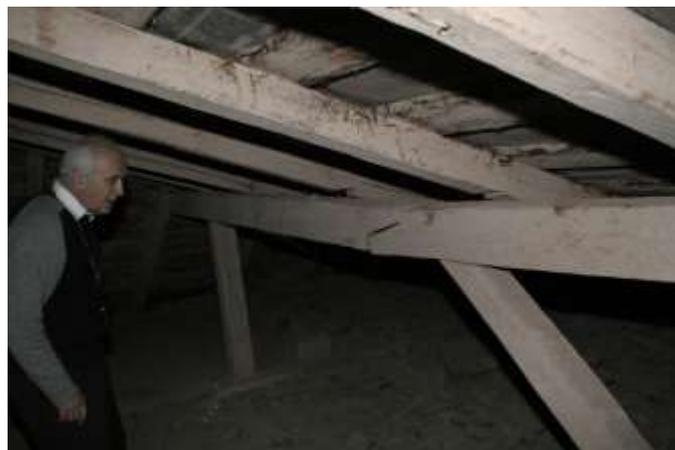
There are a lot of examples as that we found extreme deformations and torsions of elements in the roof structure because of late intervention that tried to consolidate the structure by removing certain elements and stiffen others considered more important. The effect was a transformation of the static scheme of whole roof structure that created in time tensions in elements which further in

time lead to modified the geometry of the structure.

Figure 4 - Distortions of roof structure, credits: Rares V. DRAGAN

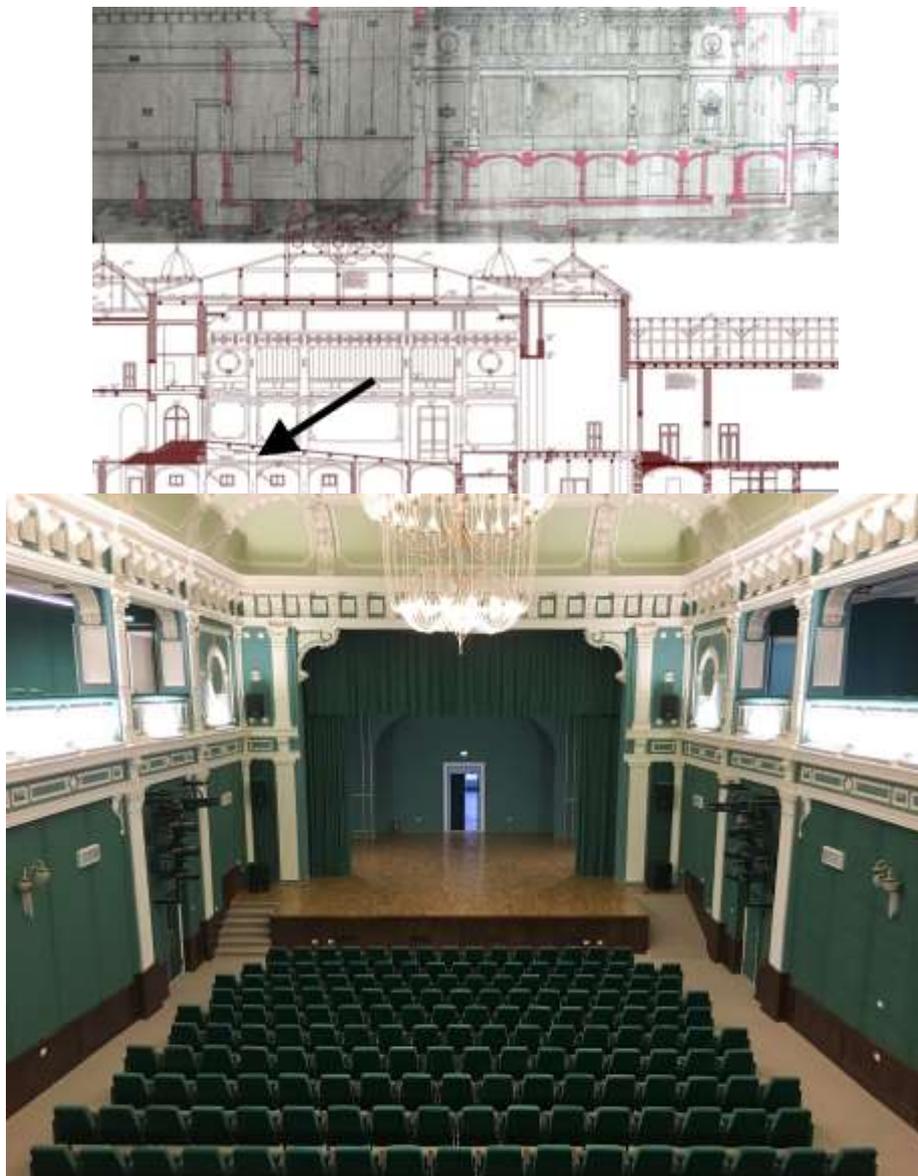
Figure 8 - Long Section, 1905 vs 1960; new unaccessible space under the floor

In order to adapt to actual ventilation needs and requirements the a new solution was adapted to be able to pump large volumes of air in the main room without using tubes or other anastetically options. The solution was to use an unaccessible space that was created under the main room floor when the floor was lifted in the '60s for visibility reasons. The solutions was to open the floor under the seats, clean it, and make it an ventiation air buffer that would bring fresh air to almost each seat. The space was equipped with filtered and treated air input and 200 ventilation

grids under the seats in order to produce good ventilation with low air velocity and sound.
