Flat slabs with spherical voids. Part II: Experimental tests concerning shear strength

Abstract

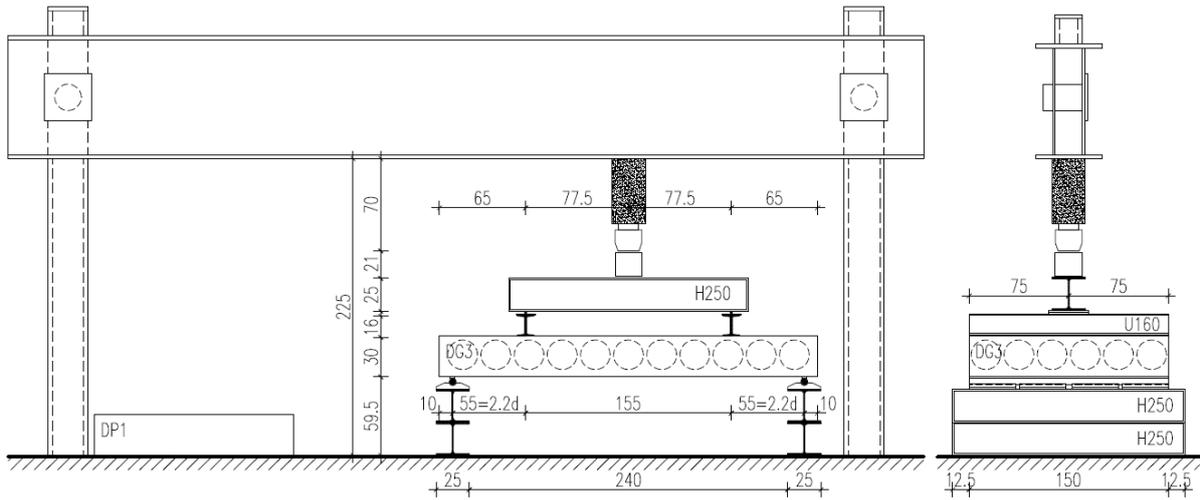
The tests were made on four point bending. As shown in Fig. 1, the test bench was made of steel profiles with H section connected with bolts. The elements were loaded until breaking in a single phase.

Figure 1. Test bench

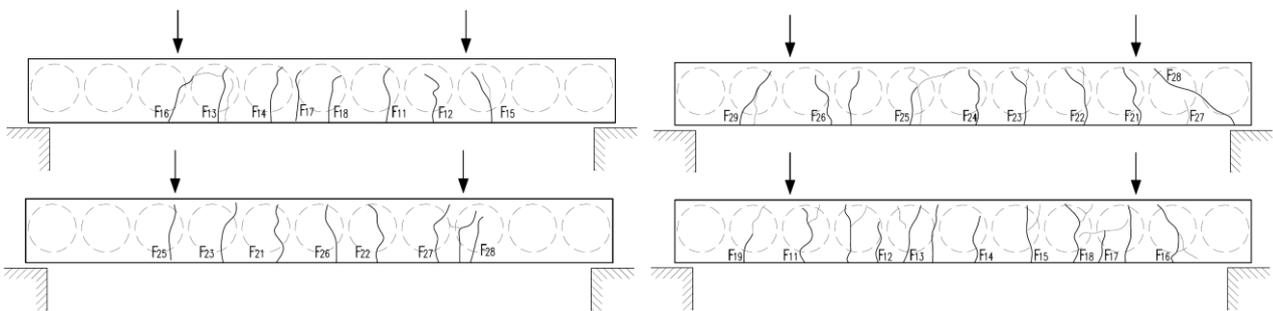
The DG1 and DG2 elements had a similar configuration, except for the a/d ratio ($a/d=2.4$ for DG1 and $a/d=1.8$ for DG2). The minimum longitudinal reinforcement percentage was used, according to EC2. For DG1 the first perpendicular cracks were observed in the median zone on both lateral sides of the slab. The value of force at this point was $F_{cr1}=120\text{kN}$. Further on, the cracks extended to the length of the element but no farther than the force position (Fig. 2). No inclined shear cracks were observed. Length and opening of the cracks were monitored until the opening for a crack reached values equal to 0.5mm , corresponding to $F'_{cr1}=180\text{kN}$.

Figure 2. Cracks for DG1 (left) and DG2 (right)

For DG2 slab, the force which caused the first crack was $F_{cr2}=240\text{kN}$. Along with increasing the load, it can be noticed that the cracks exceeded, as opposed to DG1, the load position. Moreover, shear cracks appeared for a force equal to $F'_{cr2}=460\text{kN}$.

If the spheres and cracks position are overlapped, it can be observed, as shown in the figure 2, that for both slabs, the cracks' position coincides with that of the spheres. Furthermore, most of the cracks were positioned in the central area, between force positions.

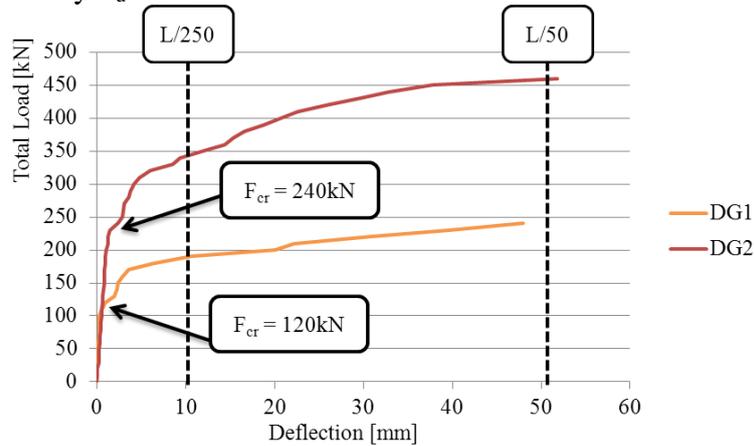
Figure 3 presents the force-deflection relationship recorded for DG1 and DG1 slabs. In Figure 3 it can be observed the failure, for both elements, that was produced by the yielding of the reinforcement at the same time with excessive deflections. This behavior resulted in big openings for cracks, more than the limit imposed by service load criteria. The test was discontinued when a deflection equal to $L/50=51\text{mm}$ was observed. The force recorded for this deflection was $F_u=240\text{kN}$

with first slab, respectively $F_u=460\text{kN}$ with the second one.

Figure 3. Force-deflection diagrams – elements DG1 and DG2

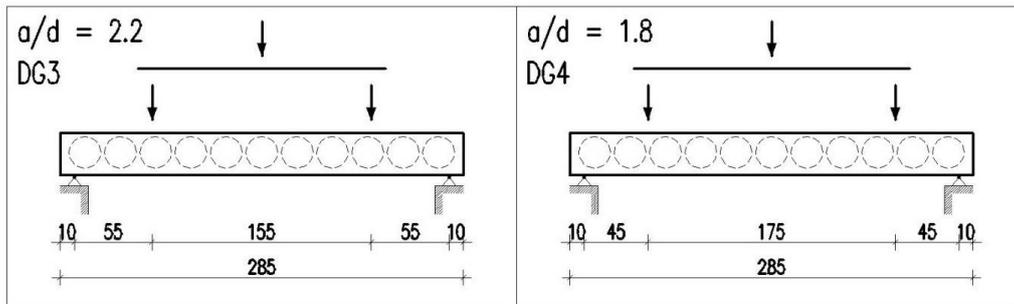
The a/d ratio varied for the slabs in this series as well. The DG3 and DG4 slabs had the same geometrical characteristics and mechanical properties for concrete. The DP1 plate was tested in the same conditions as the DG3 slab. The difference between the slabs came from the percentage of reinforcement used. The main parameters observed were the vertical deflection relative to applied load, the development of cracks along the lateral sides of the element and the strains in the transversal direction of the slab.

Figure 4. Test set-up for DG3 (same for DP1) and DG4

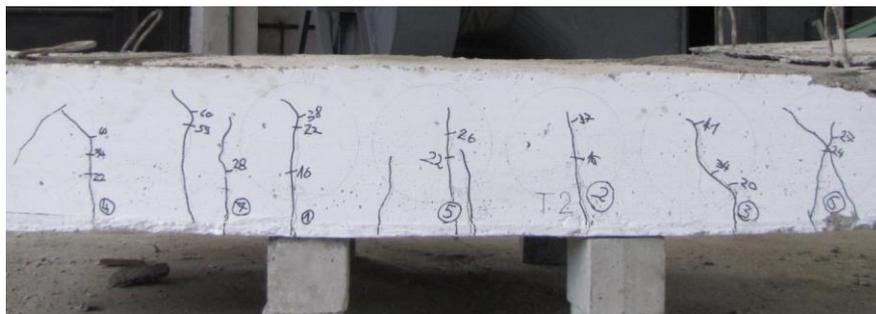
The first cracks, perpendicular to the longitudinal axis of the element (Fig. 5), were noticed for a load of $F_{cr1}=160\text{kN}$.

Figure 5. The central cracks positions on the longitudinal face – element DG3

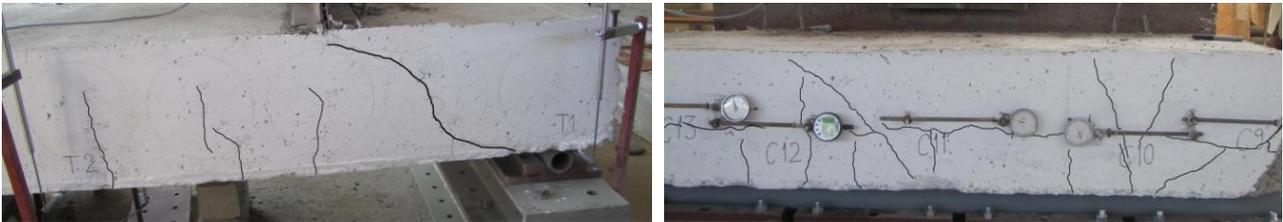
The first inclined cracks appeared between supports and the load lines for a total force of 363.6kN (F_{cr2}). The opening for inclined cracks was evaluated until the recorded value reached $w=0.3mm$, for a total load $F'_{cr2}=460kN$. For this force the perpendicular cracks had the opening around 0.20mm. After the inclined cracks were observed, closely to the ultimate load value, it can be noticed vertical and horizontal cracks on the short lateral side of the element (Fig. 6). This behavior can be explained by the occurrence of the transversal tensile stresses, which appears due to the blocking effect of spherical voids in the flowing direction of the compressive stresses trough the concrete strut. The horizontal cracks appeared in the slab median zone intersecting the smallest concrete sections which connect the bottom and top side of the slab.

Figure 6. The cracks positions on the lateral and transversal side of the element DG3

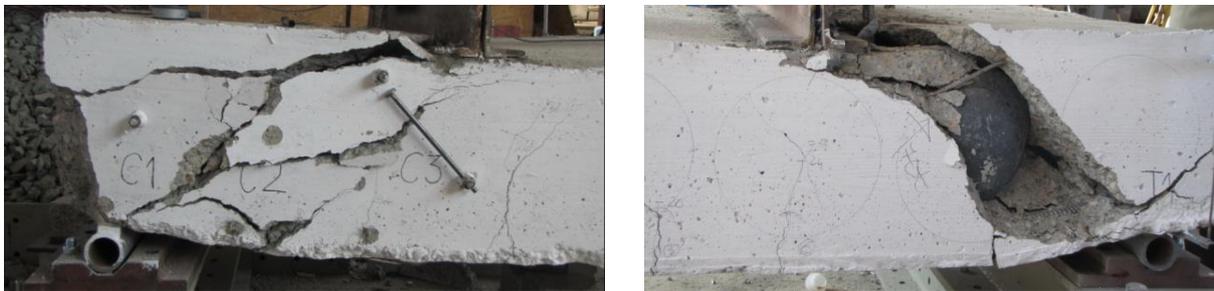
Breaking came suddenly by stroking the compressive concrete through crack F9 at a maximum load of 756kN (Fig.7). The maximum deflection, recorded at breaking point, was about 31.3mm (Fig. 8).

Figure 7. Breaking moment – element DG3

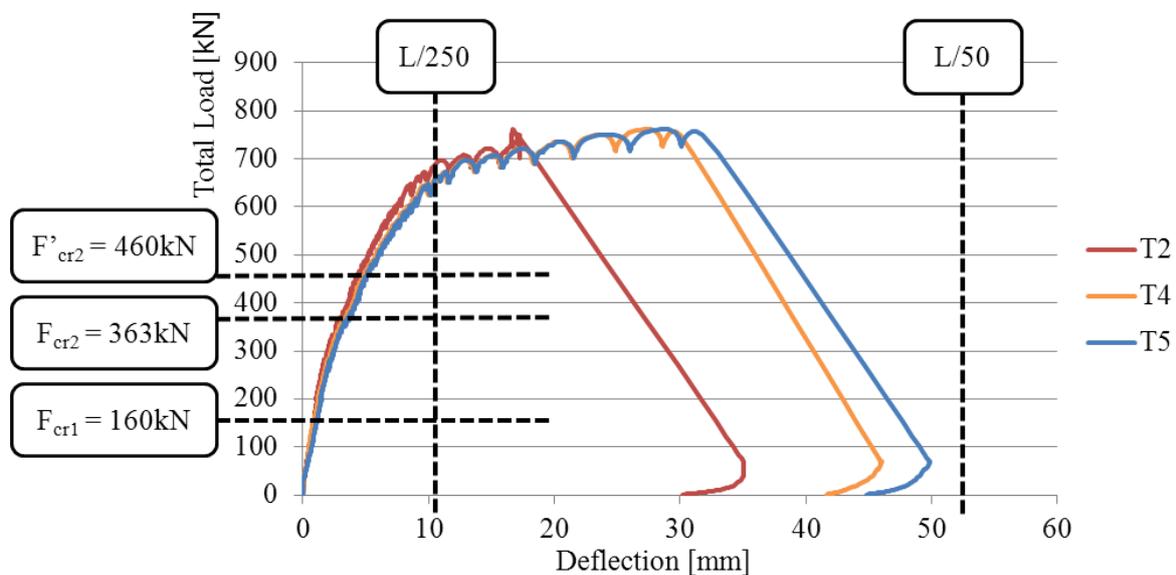
Figure 8. Force – deflection diagram for element DG3

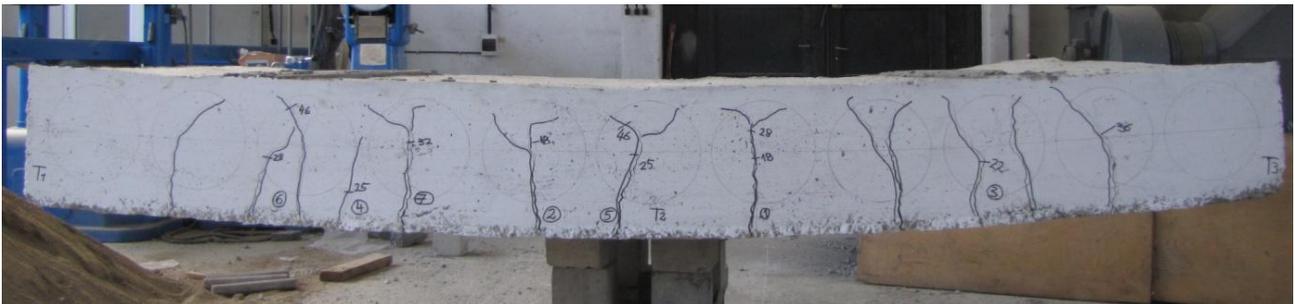
The first cracks were found in the median area of the element, for a force $F_{cr1}=182kN$. With the increasing of the force, the cracks extended over the entire area between the force positions. There also appeared cracks in the area between the forces and the supports, in close proximity of the forces positions. The opening and lengths of the cracks were measured until the value reached $w=0.3mm$, at an intensity of $F_{cr2}=335kN$. Figure 9 illustrates the crack configuration on the longitudinal face of the element. In this case there were no cracks on the short lateral side of the element.

It can be noted that towards the edges of the slab, in the vicinity of the stands, the normal cracks developed towards the compressive area, tilted against the axis on the length of the element. The explanation underlying this phenomenon resides in the fact that the concrete blocks between the cracks were subjected to bending as simple cantilevers and the reinforced slab transforms into a comb-like structure. Also, it can be seen from figure 9 that the cracks appeared in front of the transversal voids lines.

Figure 9. Cracks review on lateral side – DG4 slab

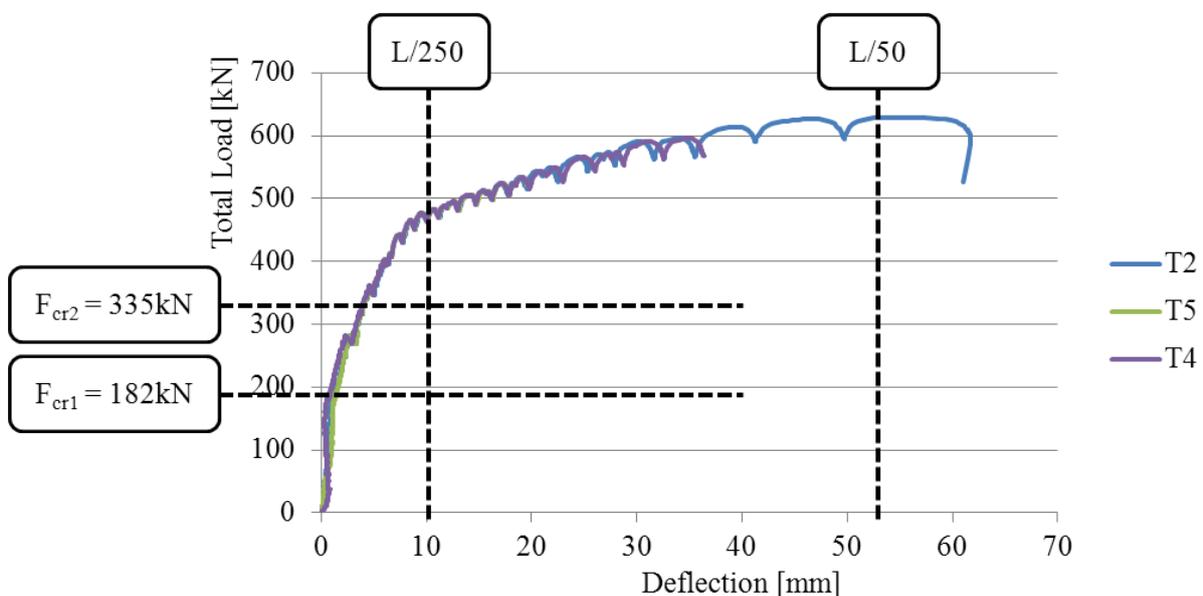
The DG4 slab failed under the bending moment. The test was stopped after the longitudinal reinforcements had exceeded the yield strength and the vertical deflection increased the limit value of $L/50=53mm$. The maximum deflection located in the middle of the slab measured 61.7mm. Figure 10 illustrates the force – deflection diagram for DG4.

Figure 10. Force – deflection diagram for element DG4

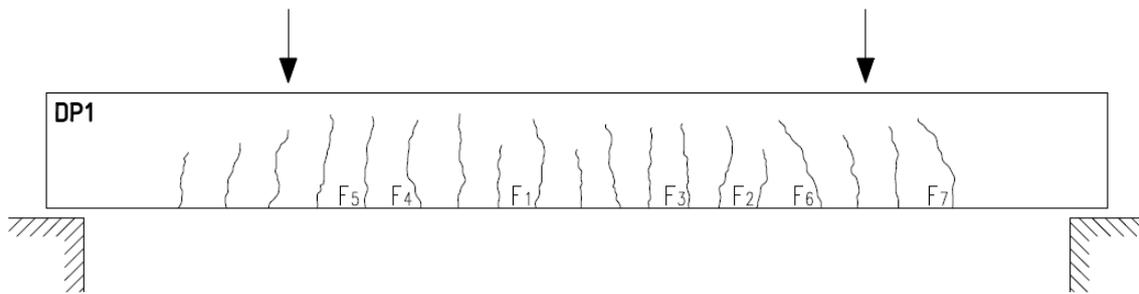
At the maximum force of 680kN and a corresponding vertical deflection of 25mm , the test came to an end due to technical problems which had occurred before the slab could be considered failed. The first vertical cracks appeared in the central area of the element, at a force value of $F_{cr}=202\text{kN}$. The cracks escalated across the entire length of the slab, and towards the stands they went beyond the force positions. The cracks between the stands and the forces evolved to the compression zone in the upper end, inclined against the slab longitudinal axis (Fig. 11), yet less obvious as compared to the DG4 slab. Figure 11 presents the crack survey, and it can be noticed the orderly arrangement of the cracks, at a shorter distance than in the case of hollow slabs, where cracks tended to develop mostly in front of the hollows.

Figure 11. Cracks review on lateral side – DP1 slab

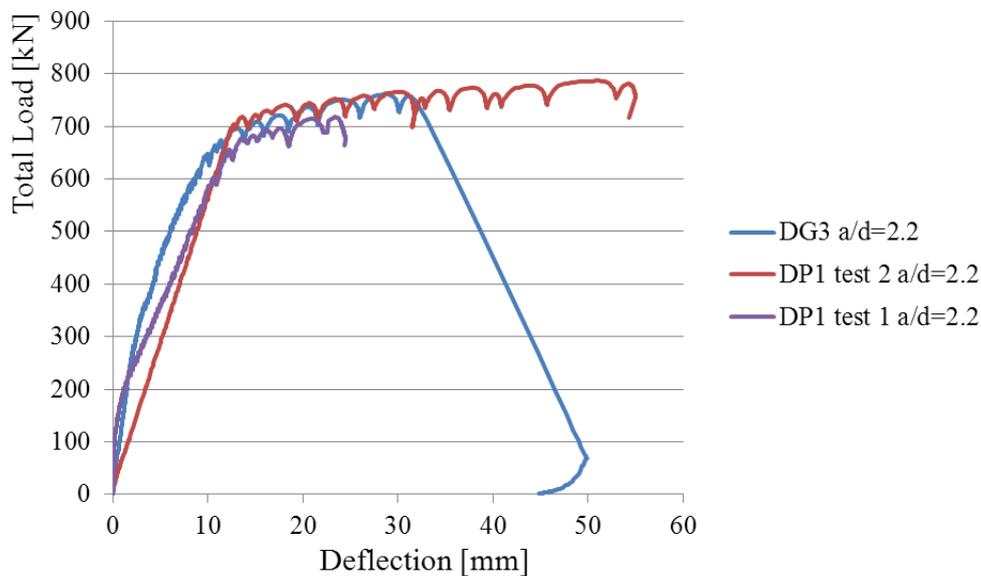
Since the tested element has not exhausted its bending strength, the experiment was resumed later, and the only measurements that have been carried out were in relation to the value of the force and the three-point vertical deflections in the central part of the slab. The second loading cycle was stopped after the boundary limit of $L/50$ for the maximum deflection was exceeded. The slab failed due to bending moment, developing excessive deflections, along with the increase in the cracks openings. No inclined cracks developed in the shear force action area. The curves for the two loading cycles and the curve corresponding to DG3 element, are presented in Figure 12 below.

Figure 12. Force – deflection diagram – element DP1 and DG3
