Flexural Performance of Reinforced Concrete Beams Strengthened with Composite Materials

Catalin Andrei Neagoe^{*1}

¹ Technical University of Civil Engineering Bucharest, Faculty of Civil, Industrial and Agricultural Buildings, Lacul Tei Blvd., no. 122-124, 020396, sector 2, Bucharest, Romania

(Accepted 28 August 2013; Published online 2 October 2013)

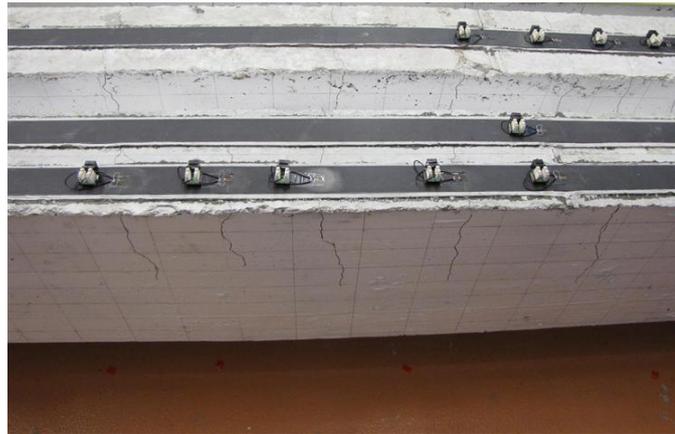
Figure 3. Positioning of the strain gauges above the flexural cracks.

Electrical strain gauges were attached on one half of each beam in order to measure the strains in the CFRP strips. The gauges were fitted to match the flexural cracks developed in the preloading stage (Fig. 3). Additional strain gauges were positioned on the compressed top face of the concrete.

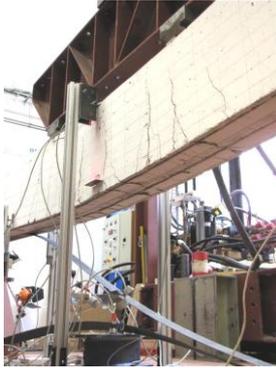
Figure 4. Mid-span debonding of FRP initiated by a flexural crack.

Failure modes fell broadly into two groups: those initiated by flexural cracks within the constant moment zone (Fig. 4) and those that occurred within the shear span of the beams (Fig. 5), initiated by shear cracks. For specimens B01-I-1L, B03-II-1L and B04-II-2L the debonding initiated in the

pure bending region and then propagated towards one of the supports. The debonding plane occurred a few mm inside the concrete cover and in some places along the interface, near the adjacent adhesive layer. For B02-I-2L the debonding occurred earlier than for the other retrofitted beams, the main reason leading to this was the higher shear stress concentration, near the plates' ends. The debonding plane was observed inside the concrete cover along the steel reinforcement.

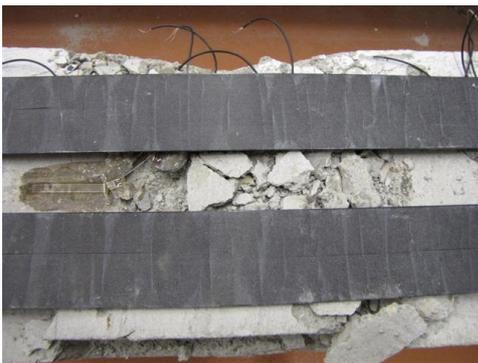
Figure 6. Detail of the middle of the CFRP strips.

After failure of the tested beams, observations were made concerning the impregnated patterns on the face of the CFRP strips that were in contact with the epoxy adhesive. As shown in Figure 6, for the beams where the debonding started in the middle, initiated by flexural cracks, there was a pattern that described the way the interfacial stresses were transferred during the loading stage.

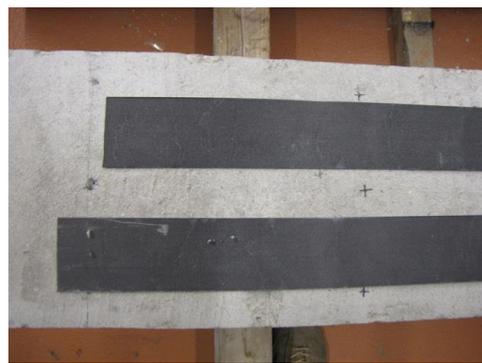
Figure 7. Detail of the ends of the CFRP strips.

However, the ends of the plate did not show any patterns, sign that they were pulled-off when failure occurred (Fig. 7). Figures 8-11 show the determined experimental strain profiles for the CFRP strip(s), from the high moment region to the plate's end, from zero to maximum force value. Graphics were computed for one half of the beam for symmetrical reasons. Similarity between the real and the measured strain profile is higher at lower loads while at levels closer to the maximum load, the experimental behavior becomes more irregular, probably due to the development of cracking, which the linear model simulates more roughly.
