Reinforced Concrete Frames with Masonry Infills. Out of Plane Experimental Investigation

Cristian Petrus^{*1}, Valeriu Stoian², Marius Mosoarca³, Anthimos Anastasiadis⁴

Keywords: masonry infill, seismic behavior, out-of-plane, damages, consolidation measures

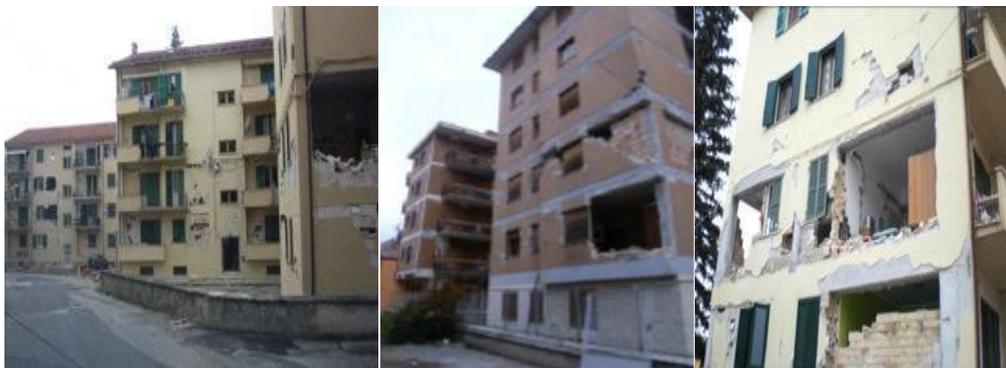
Figure 1. Examples of in-plane and out-of-plane seismic damage to clay unit masonry infill walls.

Recent seismic activities revealed that a lot of structures having masonry infills recorded an extensive amount of damage. These walls can detach from the structure and collapse, due to a combination of in-plane and out-of-plane demand, as it can be seen in figure 1. The out-of-plane failure of the enclosure walls, are dangerous, causing fatalities and large economic loss, as it was the case for the L'Aquila, Italy earthquake from 2009, which had a magnitude of 6.3 on the Richter scale [3]. Widespread extensive damage of the masonry infills and partition walls caused the highest losses in reinforced concrete buildings. A detailed analysis was carried out after the seismic event in order to evaluate the repair costs for the clay units of the infill walls, equipment and interior finishing [4]. This analysis pointed out the fact that the costs related to the enclosure walls repair, even in a severe earthquake, can be more relevant than the cost related purely to structural interventions [5]. Such is the case of veneer walls which are susceptible to cracks and failures in case of poor detailing of the connection to the reinforced concrete bearing structure, figure 2.

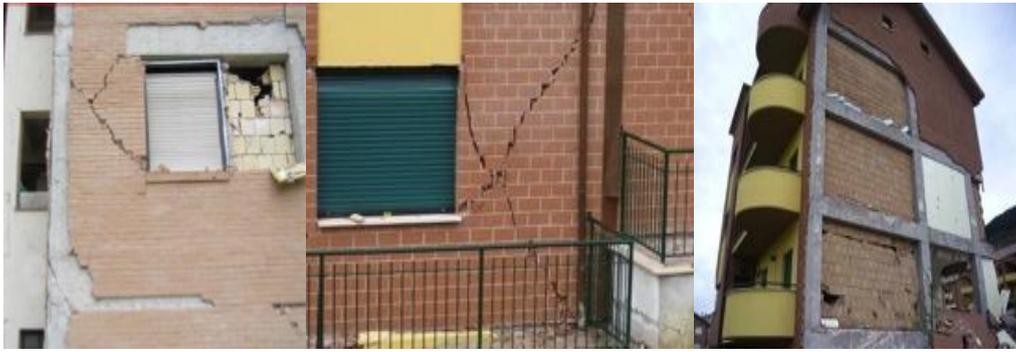
Figure 2. Examples of in-plane and out-of-plane seismic damage to clay unit masonry veneers.

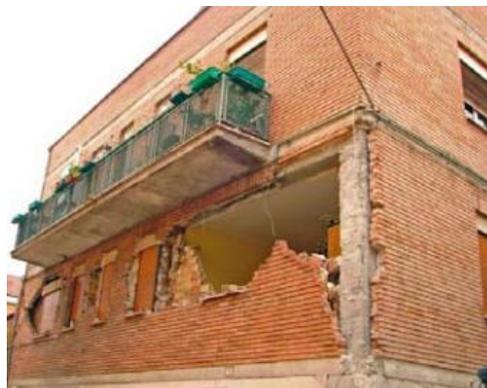
Figure 3. Typical damage of infill wall after the L'Aquila, Italy earthquake.

Figure 3 presents the failure of the masonry infill and veneer wall of a relatively new building, after the earthquake from L'Aquila. Poor constructive detailing can lead to damages in buildings which were constructed previous to modern seismic design codes, but even in newly constructed buildings, thus a call for the development of new and improved systems is necessary. Examples of in-plane and combined in-plane and out-of-plane damages can also be observed in newly constructed buildings from Emilia, Italy, after the 6.0 magnitude earthquake from 2012 [6], as it can be seen in figure 4.

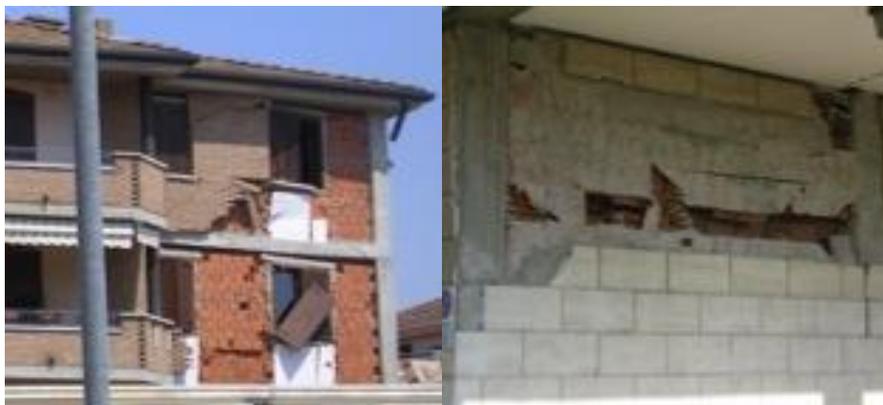
Figure 4. Masonry infill and veneer damage after the earthquake from Emilia, Italy.

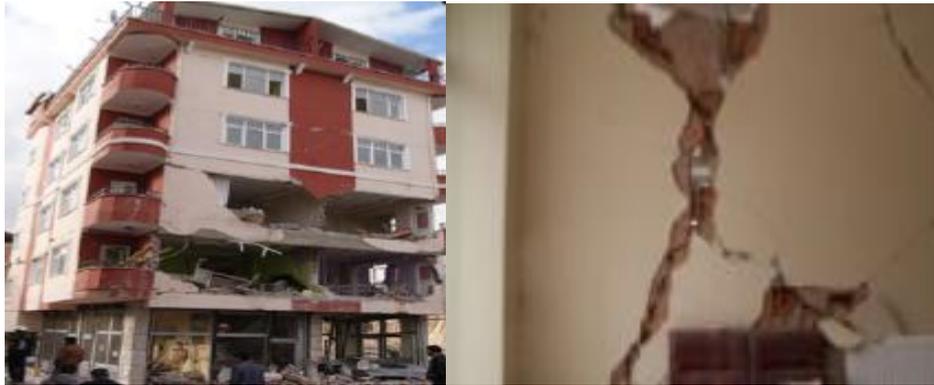
Figure 5. In-plane and out-of-plane failure of masonry infills after the Van, Turkey earthquake.

other situations, the masonry infills detached from the structure, as it can be seen in figure 5, due to combined in-plane and out-of-plane solicitations, proving a dangerous failure mode for the occupants.

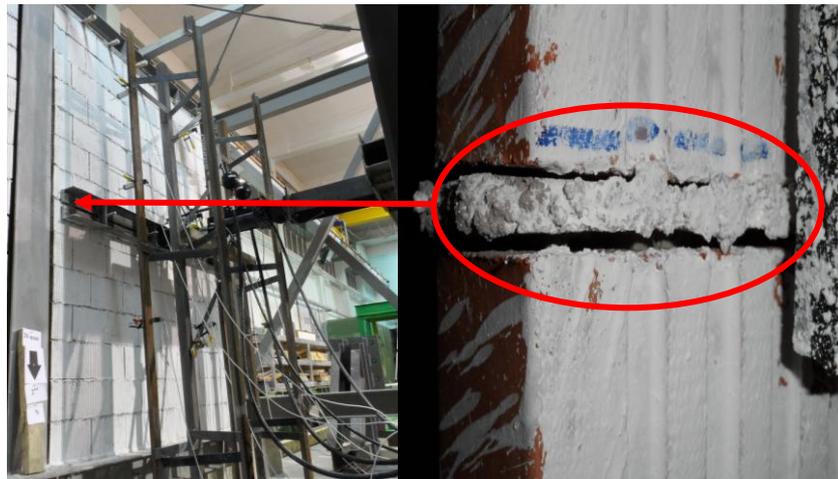
Figure 12. Experimental setup and opening of horizontal crack in MW1

At a displacement of 10 mm, a horizontal crack appeared in the horizontal mortar layer, followed by horizontal cracks at the bottom part and top part of the masonry wall. Increasing the displacement, the crack in the middle part of the wall opened as much as 8 mm, as it can be seen in figure 12.
