Banat's Last Wooden Churches and How to Save Them

Using Crivina de Sus Wooden Church as a Case Study

Diana Belci^{*1}, Bogdan Ilieș²

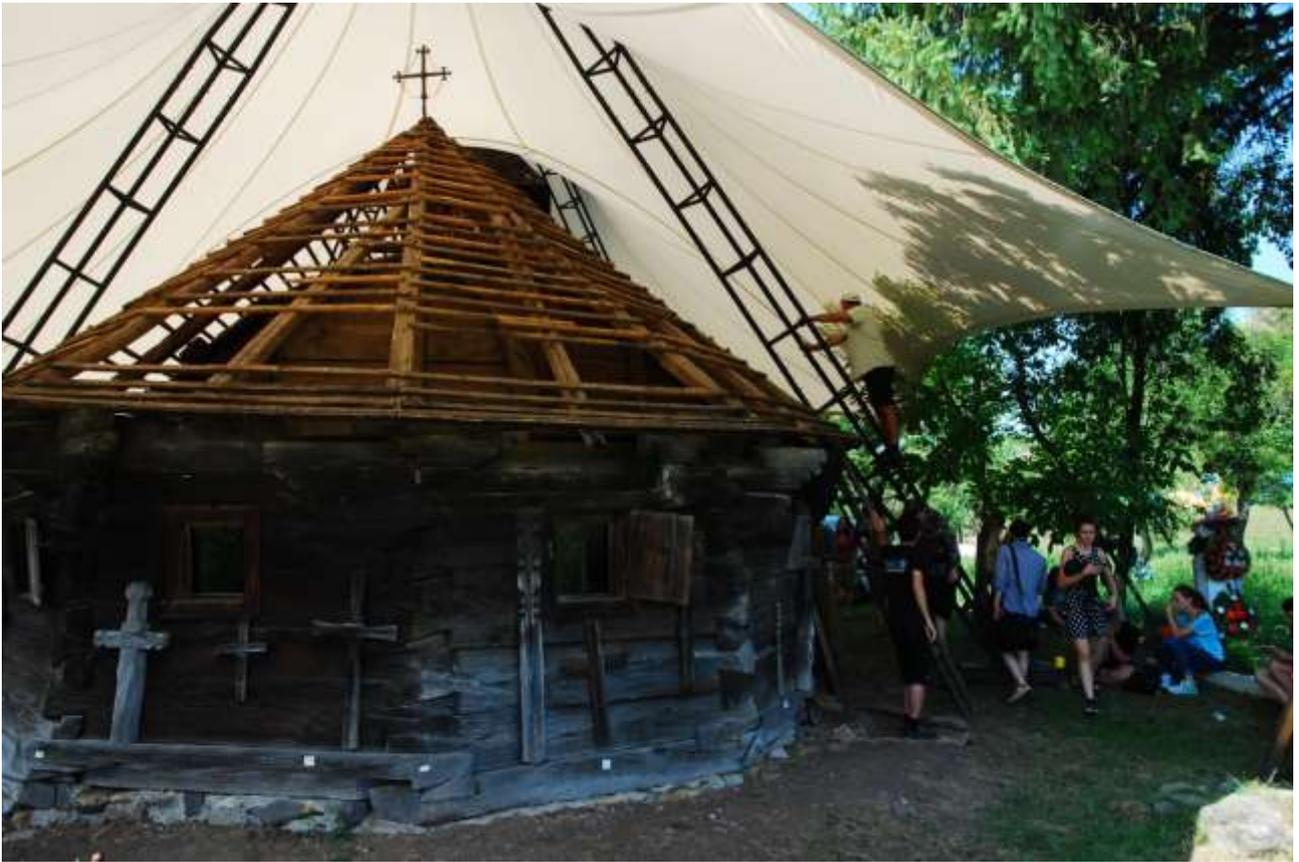
Figure 2. Workshop under the tensioned membrane in Crivina de Sus.

The Crivina de Sus project also had a different component: building a tensioned membrane to protect the church until the money for the restoration project is collected. This membrane has made it possible for the shingle cover to be removed, allowing numerous studies to be made. Thus, a series of precious information were obtained, among which the fact that the church was probably painted at some point. This can be read in the church's attic, on the back of the tympanum separating the naos from the pronaos, where traces of paintings were discovered. Probably the original painting was damaged during the transport from Ilia to Crivina de Sus, but the painted planks were re-used. The attic of the church is full of elements that have been reused, rich with carpenter signs. One of the pillars that secures the tympanum planks is, in fact, an old funeral column dating back to 1760, probably belonging to one of the first priests in Crivina, namely Ioan. If the roof frame in Crivina would have been changed like in Poieni, all this information would have vanished.

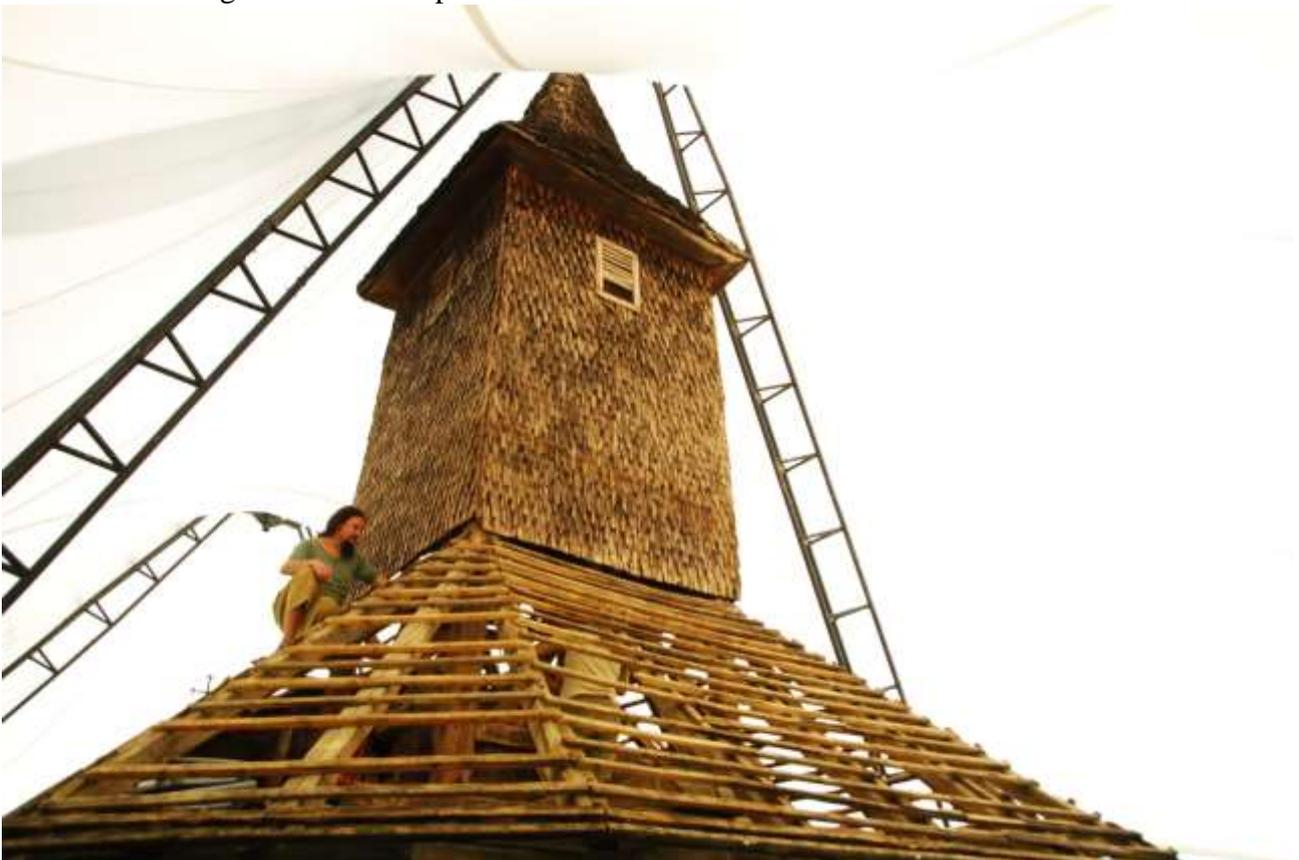
Figure 1. View of the open roof framing in Crivina de Sus.

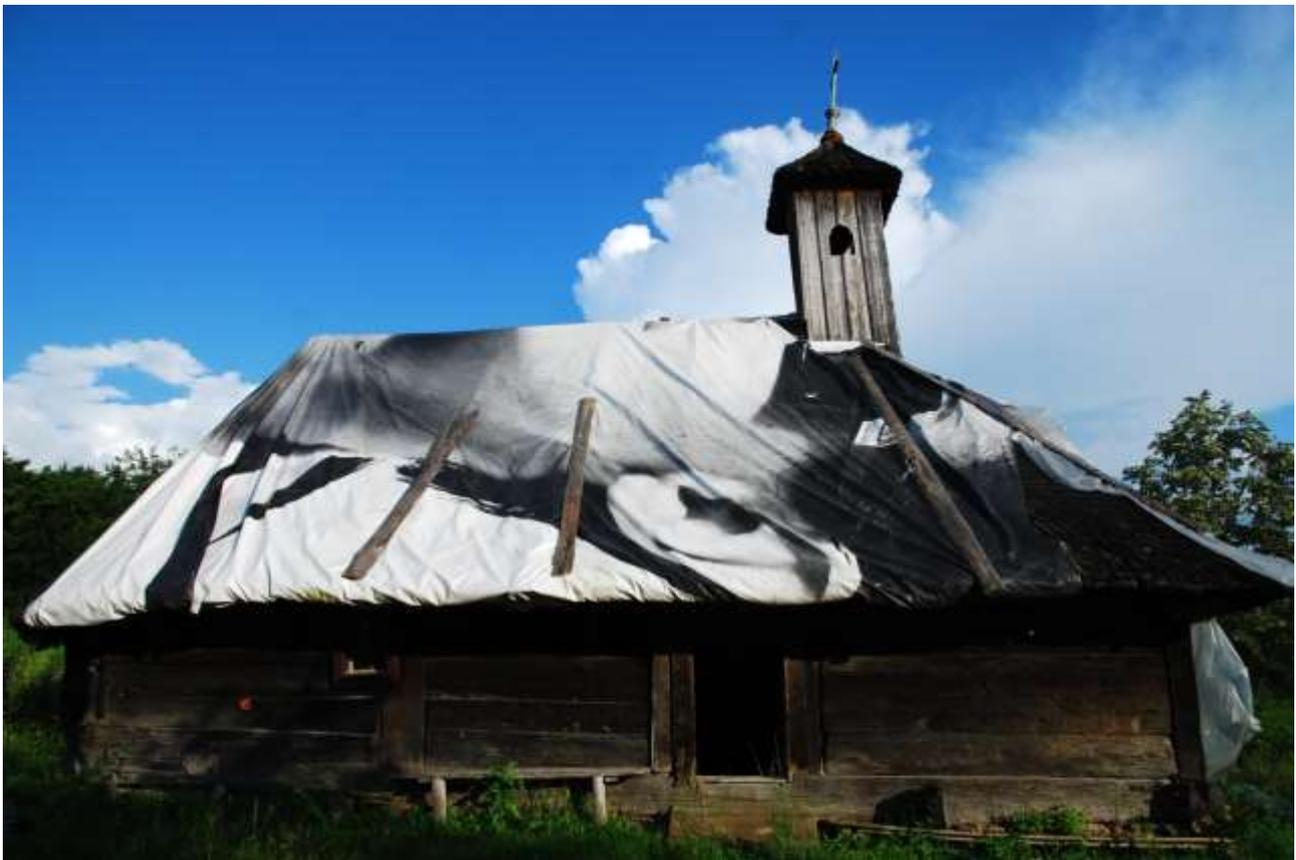
Figure 4. The wooden church Cuvioasa Paraschiva from Jupânești

The churches of Dragomirești and Jupânești seem to be in severe condition. The Dragomiresti church needs a detailed restoration. This church could become the place where the membrane from Crivina de Sus can be moved once the restoration process has been completed. Regarding the wooden church from Jupânești, it has a very degraded shingle cover. It's the same type of shingle as in Crivina de Sus.

In Crivina, a craftsmen 's note was discovered in the attic shingle. It was written by one of the two craftsmen from Argeș that worked on the shingle shifting in 1981. It is believed that the shingle from Jupânești dates back to the same period. At Jupânești, the locals of the village placed a huge advertizing cover on the very degraded shingle to protect it temporarily. Unfortunately, frequent

raining in the summer of 2018 has shattered this improvised cover. The water infiltrated into the church interior. There is very little information about this church. Not even a precise build date is known (the researchers who studied it, believed it to be either in the 17th century or the 18th century). A dendrocronological study would resolve these dilemmas. The church appears to be one of the oldest in Banat as a typology of plan, volumetry and joints.
